# PROJECT PROFILE - SERVICE STATION DEMOLITION

New Rochelle, NY

October 2011 - March 2012

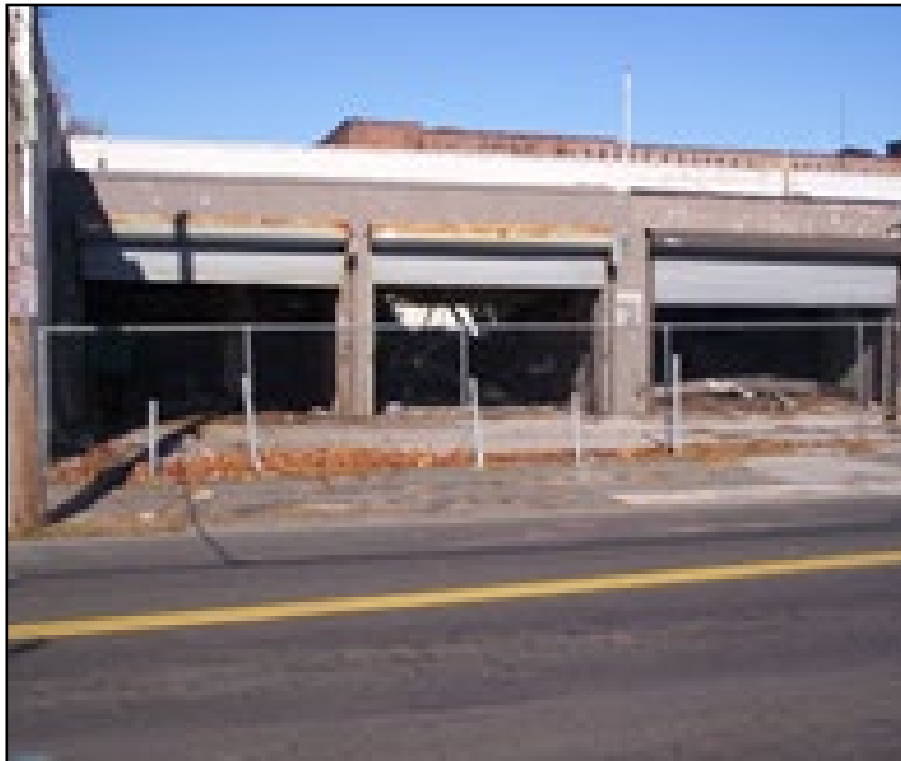
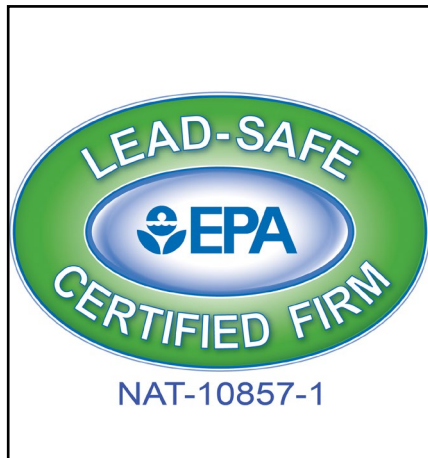
*A collapsed roof containing ACM and a common wall complicate demolition efforts.  
Upper right: completed project.*

SCE was contracted to demolish a former gas station in downtown New Rochelle, NY. Of particular concern was the building's collapsed roof. Asbestos had fallen into the building and the roof's instability prevented normal entry. To remove the asbestos, the roof was removed by men working from boom lifts and then abatement crews entered the building and removed all ACM.

With the ACM removed, the crew turned to demolition. Here the challenge involved a common party wall with an adjacent restaurant and apartment building. Supporting the party walls with steel beams, the crew demolished the building by hand with small chisel hammers while working from man lifts.
